**CLARKS BEACH
COASTAL EROSION MANAGEMENT GUIDELINES**

**Final report
May 2004**

CLARKS BEACH COASTAL EROSION MANAGEMENT ZONES

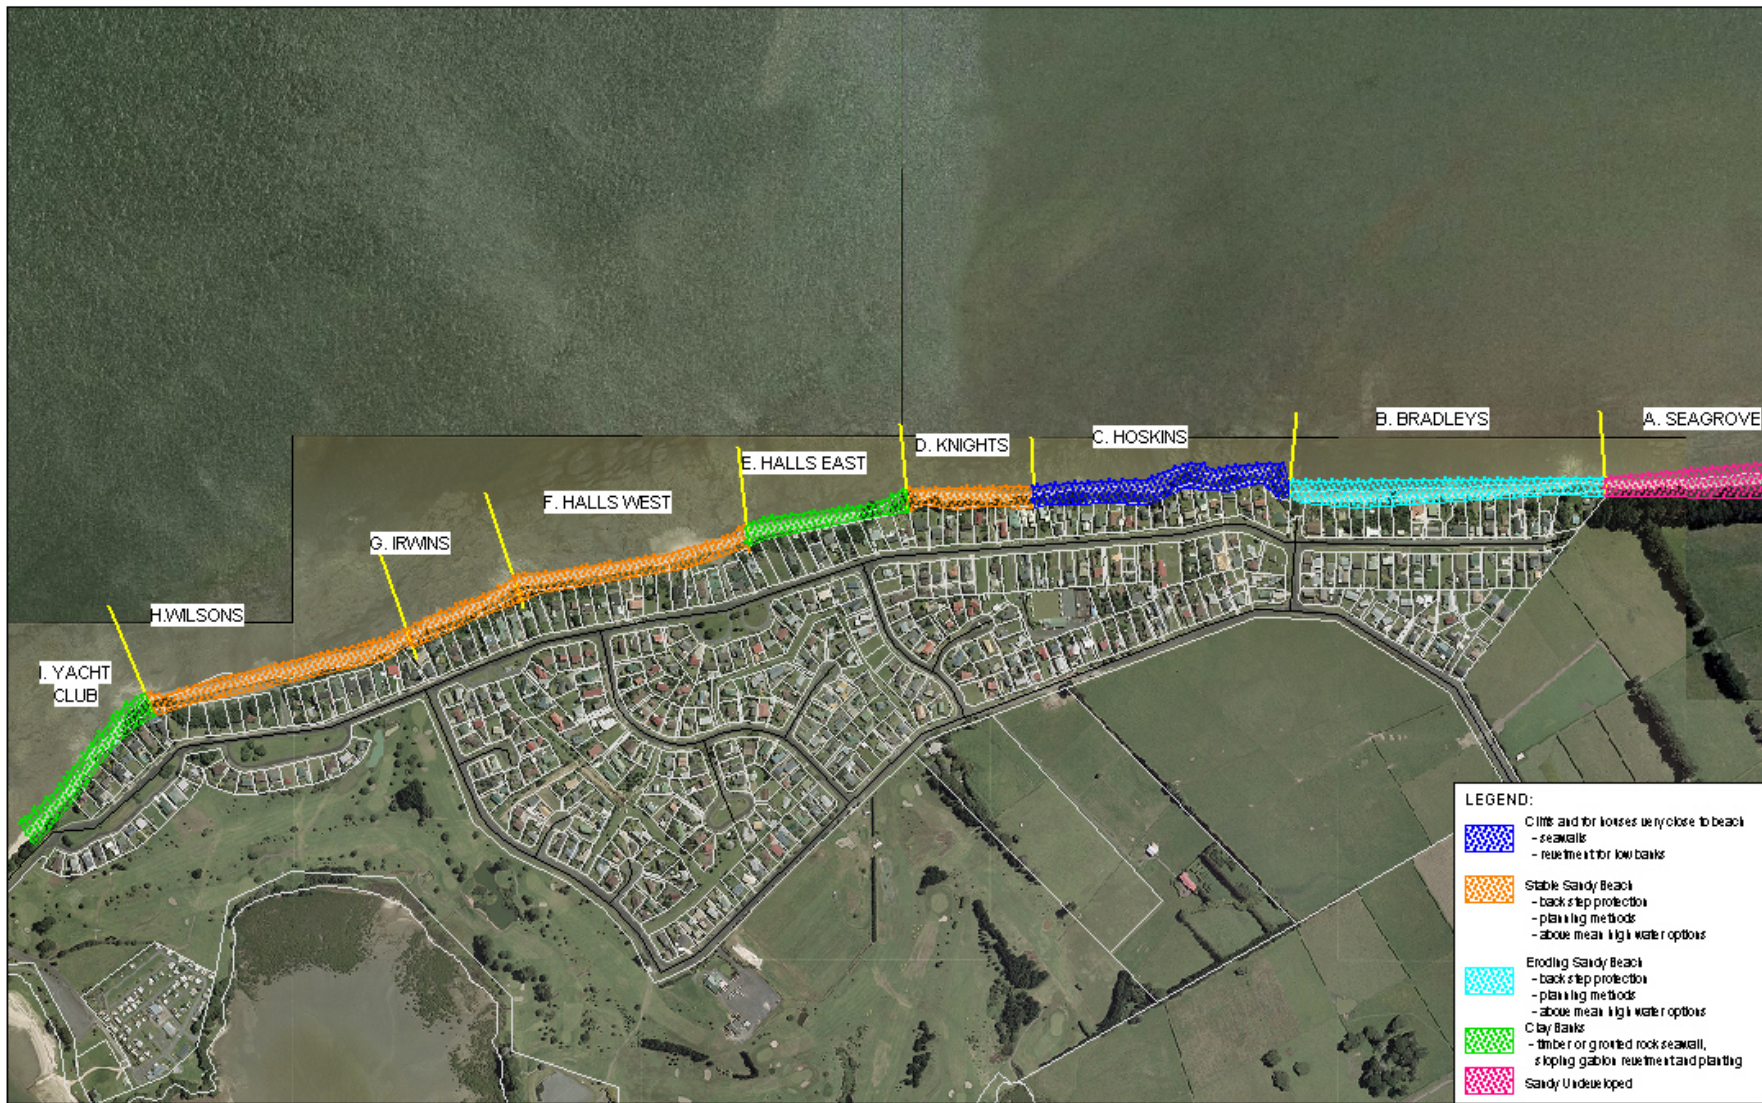
Figures 2 and 3 illustrates areas where erosion management options have been identified as potentially suitable for specific areas of Clarks Beach or Waiau Beach. The colour coding relates to the options discussed in the following sections, and the reasons why different options are considered appropriate or are not recommended area.

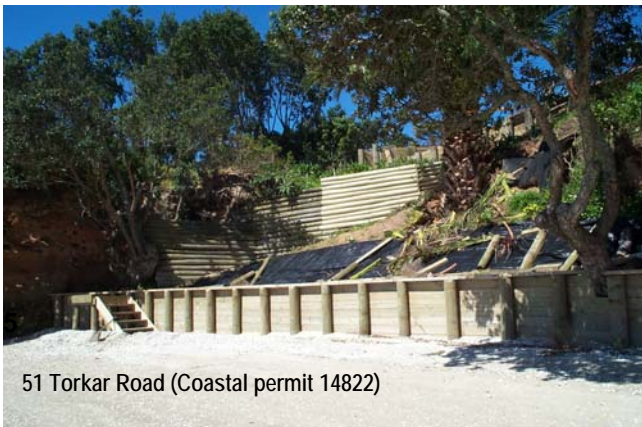
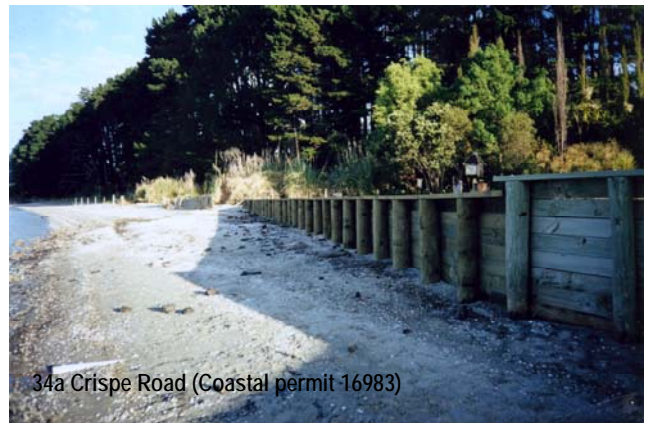
Photo 1 & 2: Examples of well constructed seawalls. Planting of native coastal species to be completed on bank landward of seawall.

- Founded on hard rock or have adequate foundations to ensure wave scour at base of wall does not undermine the structure.
- Timber to be treated for marine exposure (H6 grade) and all bolts and fastenings to be hot dip galvanized.

- If beach sediment is excavated for the foundations it should be retained and reused at the completion of the works to regrade the beach. Unsuitable excavations i.e. mud/fill should be removed from the coastal marine area.

- All work should be undertaken at low tide, and any concrete should include fast curing agents.
- Use of vehicles on the foreshore should be avoided as much as possible. If vehicles use the foreshore they should minimise the work corridor (say 15m from shoreline) and should avoid soft muddy sediment and areas of vegetation. Disturbance can be minimized by use of swamp mats or similar methods.

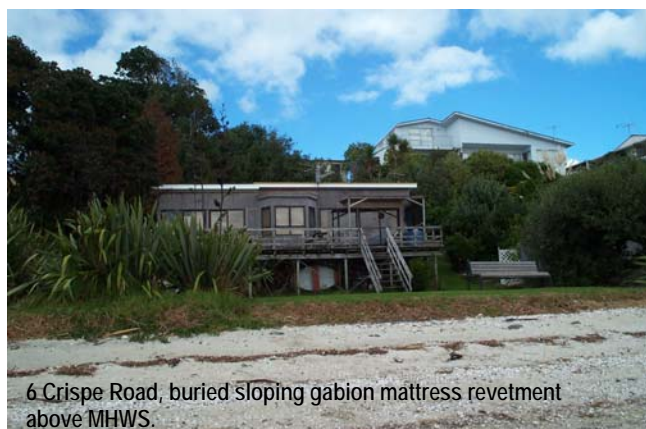
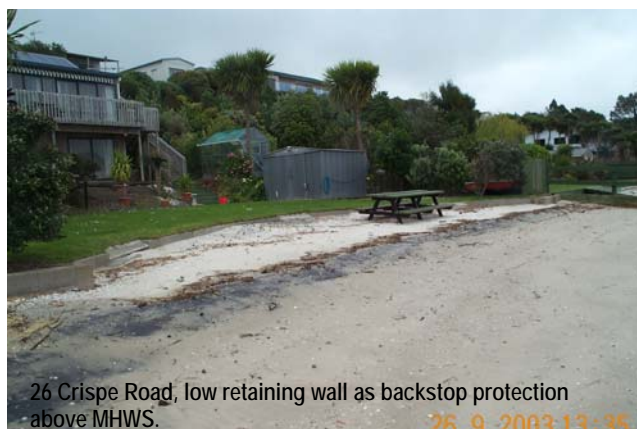
Photo 3 & 4: Examples of a backstop protection landward of the beach (above MHWS).

- An option of erosion management is a sloping revetment constructed along the backshore as a back stop to protect the property from erosion.
- The structure should be constructed as far landward as practical and follow the natural curvature of the beach to allow the natural beach to develop with minimal interaction of wave reflection from a vertical hard seawall structure.
- Revetment structures will require ongoing maintenance as sand levels fluctuate.
- Backstop retaining wall protection above MHWS minimises interaction with coastal processes and retains maximum beach width.
- Planting should be undertaken in conjunction with the revetment using low lying saline tolerant native coastal species as the root mass will help improve soil stability, and the vegetation will help to mitigate visual effects.

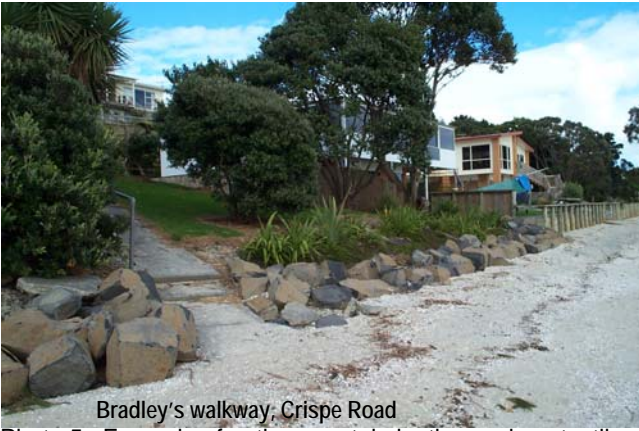
Bradley's walkway, Crispe Road

Photo 5: Example of native coastal planting and geotextile revetment with some temporary rock toe support. Geotextile revetments will not provide structural stability but can help to manage erosion by improving slope stability.
