Limited mobility access to Atiu Creek Regional Park

The park was audited using a power-assist hand cycle.

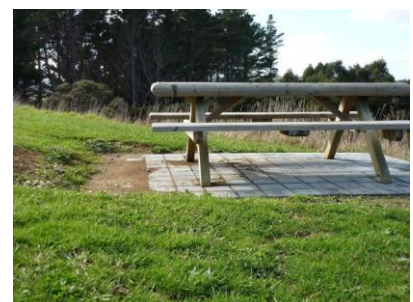
Picnic table

The picnic table has been designed to accommodate a wheelchair at the end, facing the view. Some assistance may be required to push the wheelchair to the table.

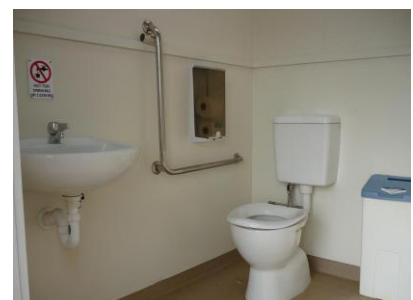
Toilets

There are wheelchair accessible toilets in the main car park toilet block. The quality of the toilets is first class with porcelain pan and basin. The fixtures and fittings are building code compliant; however there is no soap or hand drying provision.

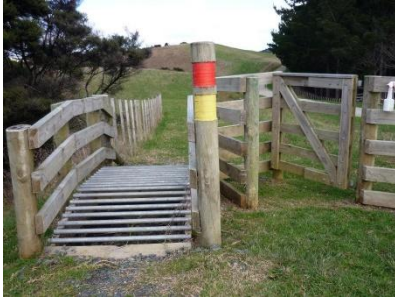
Tracks

There are two routes from the car park to the tracks. Both include cattle stops and vehicle gates that are locked, and one also includes a kissing gate. Most scooters would handle the cattle stops, however they would be challenging for wheelchairs. The width of the cattle stops on the route is 938mm. Take care as the cattle stops can be slippery, and there are steep slopes on both sides.
