Limited mobility access to Scandrett Regional Park

Areas audited

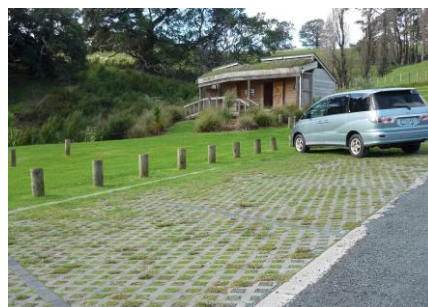
Car park

Gobi pavers comprise the surface of the car park, the gaps of which are filled with gravel and grass, so moving over them with a wheelchair or walking equipment is reasonably easy.

Parking spaces are defined in the design, but no space is designated for mobility parking.

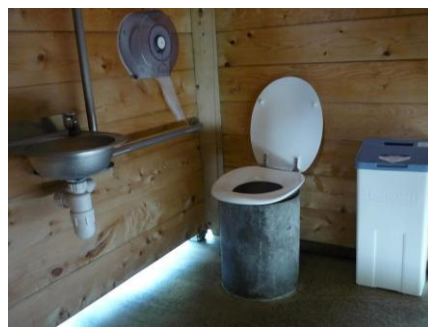
Toilets

Accessible male and female toilets are provided. The facility is approached by both ramp and steps. Pan heights are 480mm with good supportive seats and lids. The single cold water tap is a push-down water saver model.

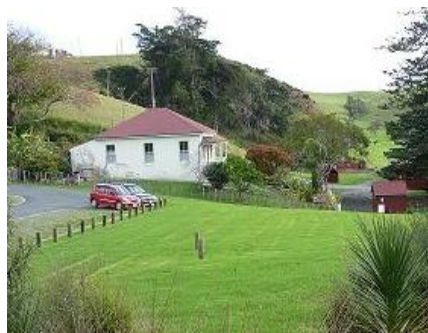
Pedestrian route to the farm buildings and baches

The route from the car park past the homestead to the farm buildings is grass and steep at the lower end. The route is particularly difficult if the grass is wet. Once at the lower level, the route via the vehicle track is accessible to the baches at the far end of the beach.
